Site Visit Report

Site Location: [REDACTED]
Visit Date: April 15, 2022
Kelsi Massengale, Partners of Scott County Watersheds

Site Summary

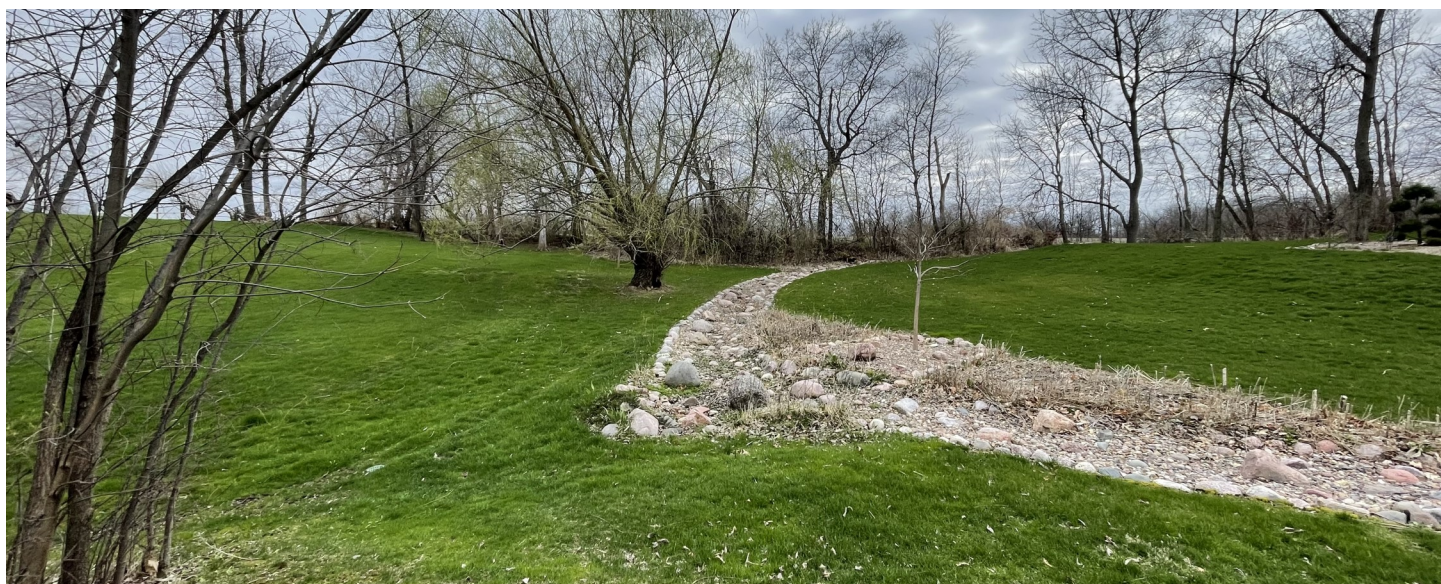
While these practices will help reduce phosphorus load, it is likely that the primary source of nutrients is from the upstream agricultural fields. A rocky path through a neighbor's yard runs directly from the field to a culvert and tile that drains to the lake (see Figure 1). It was noted that this area of the lawn used to be grassy and consistently wet, so the homeowner installed rocks for easier mowing. However, this, actually allows the nutrients from uphill to flow directly into the water. It is strongly recommended that a stretch of at least 10 linear feet of native grasses (listed in the section prior) are planted within this rock path. This will help to soak up nutrients, slow the water flow, and reduce sediment. Even if the homeowner were to install a few clumps of grasses throughout the path (as opposed to 10 linear feet) to maintain a more manicured look, it would be more beneficial than plain rock.

Figure 1: Rocky path at [REDACTED]

As an additional measure, a small native grass buffer could be installed at the confluence on the edge of the field, right before entering the rocky path. This would further help to reduce nutrients and sediment entering the lake, but may require coordination between the agricultural producer and neighbor. Some local cost-share programs may be available to help cover costs; a list of funding options can be found at <https://www.partnersofscottcountywatersheds.org/stewardship/funding/>

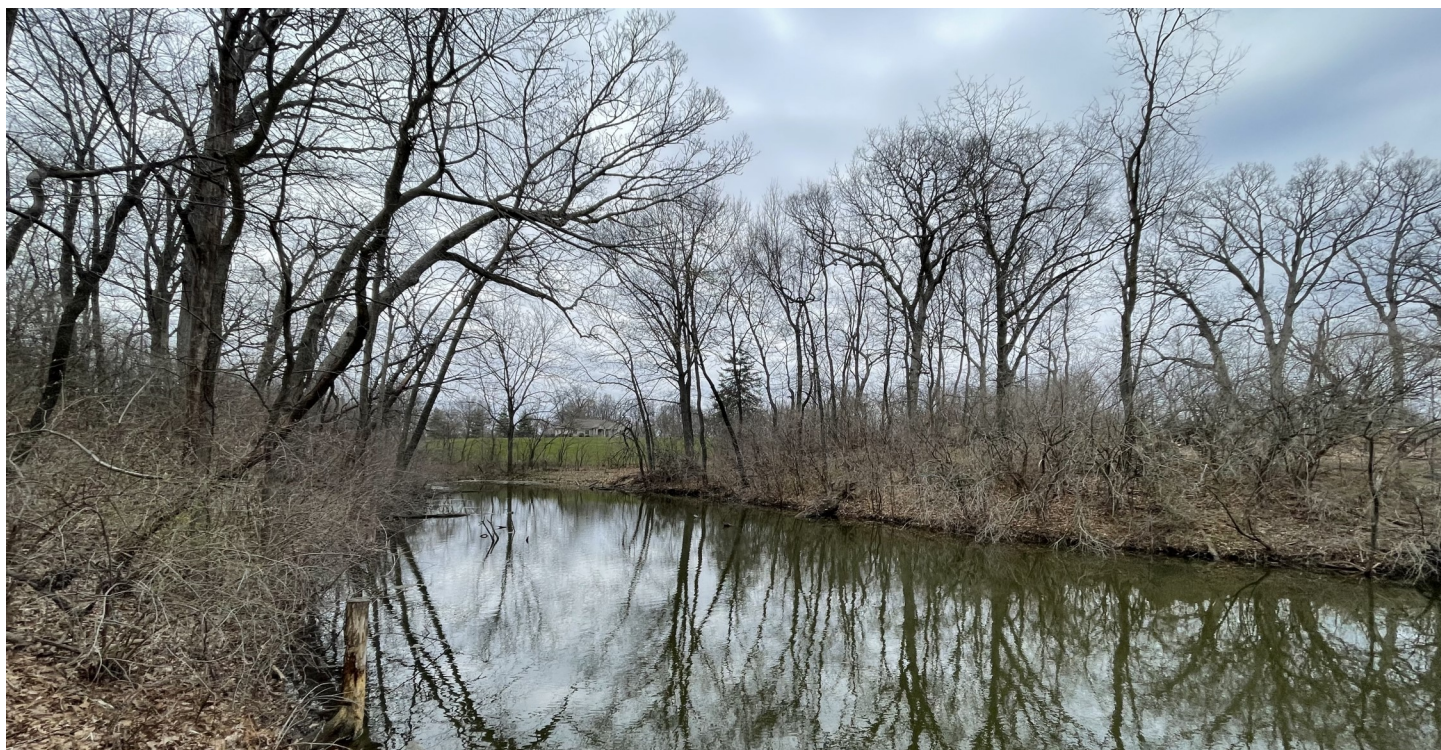
Though less direct, there is an additional drainage path coming from the upland agricultural land and lawn on the northern reach of the lake. There is a considerably larger distance between the field and lake on this side, allowing for more filtration before reaching the lake. However, much of the area between is mowed turf, which is not as efficient at slowing and absorbing nutrients as native plants. To reduce the input coming from the north, a grass buffer and/or wetland plants could be planted at the northern shore (see Figure 2).

Figure 2: Northern end of the Lake from landowner's backyard.
